**Avnet MiniZed**  
**Revision 1 Errata**  
**V1.0**  
**12 December 2017**

#### 3.1 Remote JTAG Debug Reset Does not Work

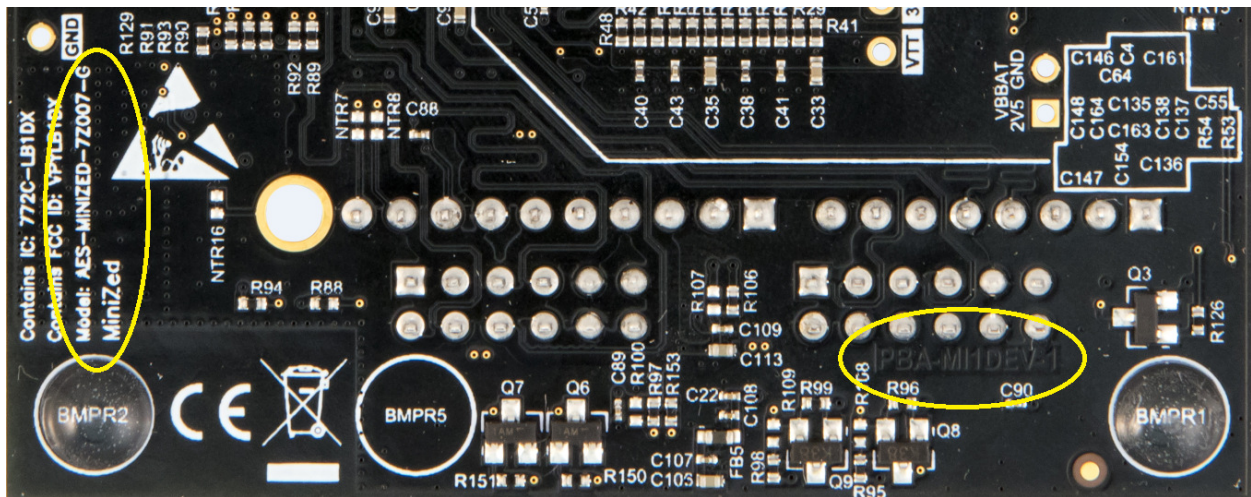
Figure 1 – Identifying MiniZedZed Rev 1 for this Errata

The image below indicates how you can verify that you have a MiniZed Rev 1 board. For a Rev 1 board, the text **PBA-M1DEV-1** is etched into the copper. Because of the black PCB this may be tricky to locate without the yellow indicator on the right in the image below. You may have to use a magnifying glass.

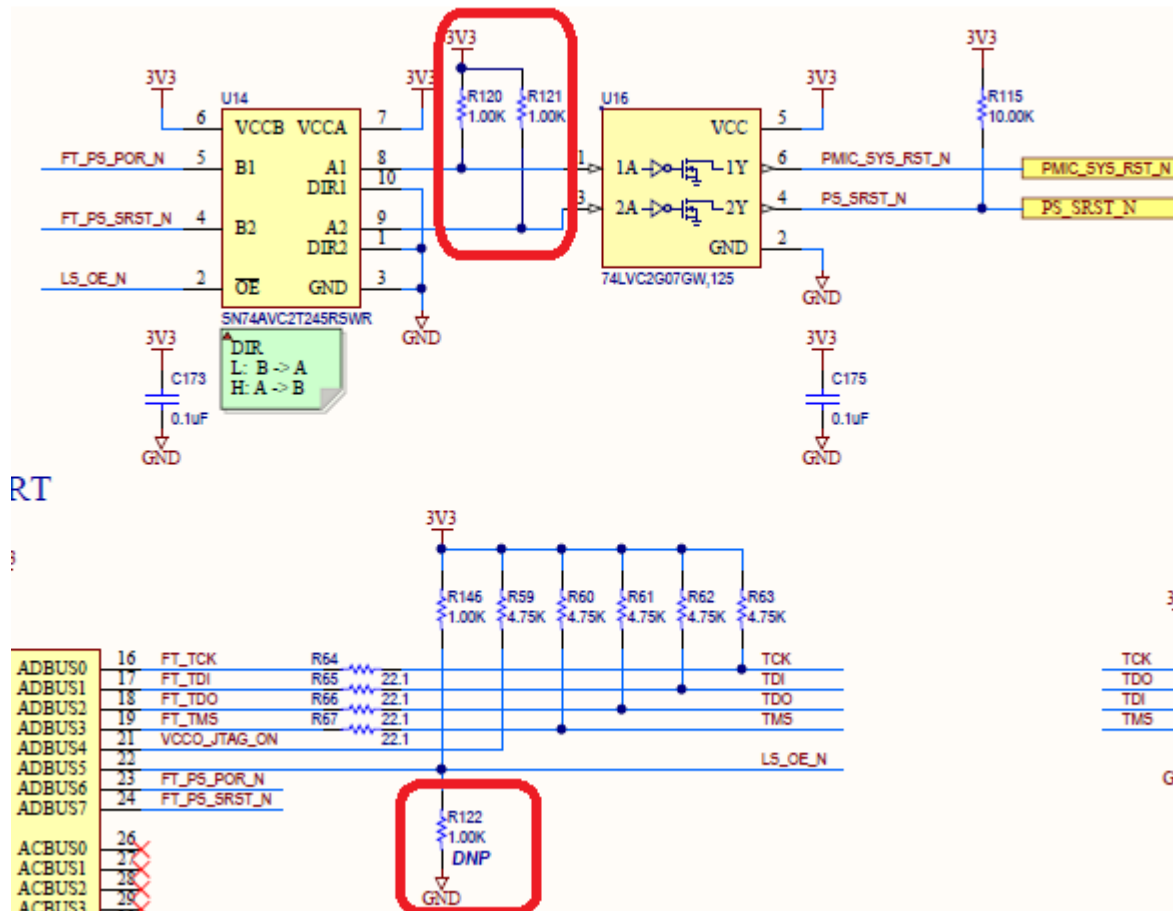
Figure 2 – Missing Resistors on the Rev 1 MiniZedZed Design

The resistors marked in red below are not on the current schematic. This is due to a design oversight, since they should have been included. Without them, it was discovered that many boards manifested an unreliable reset on power-up. This was because the inputs to U16 would float when the FTDI chip was not actively driving the LS\_OE\_N line. Because this line is under software control via the FTDI driver, it is not driven unless debug software is active.

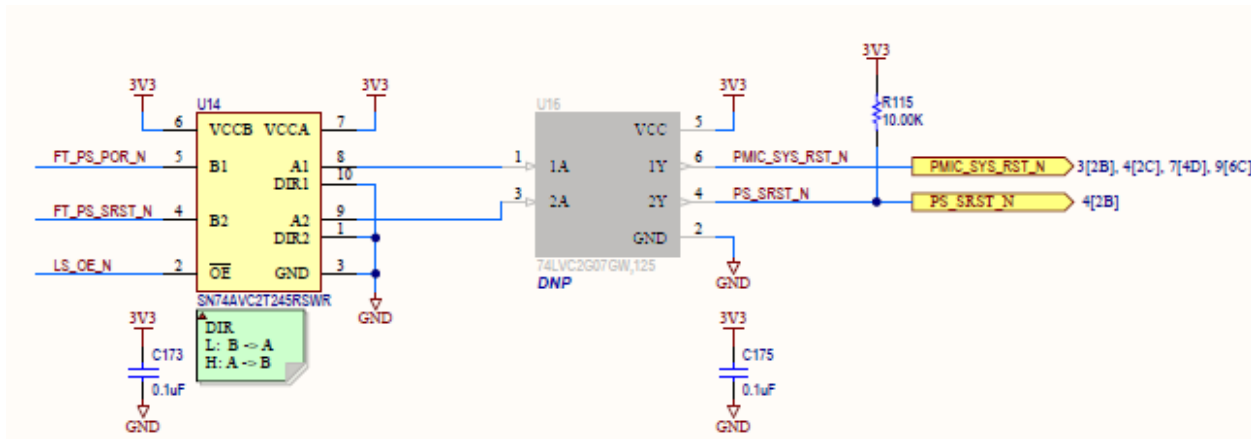
**Figure 3 – U16 Removed on Current Rev 1 MiniZedZed Schematic**

The solution (shown in the image below) was to remove U16 on the Rev 1 boards. This causes power-on reset to be reliable, but unfortunately a software reset via the JTAG driver software is not supported anymore.
